) **GWA DOCKET NO. 24-06**

10 **PETITION TO AUTHORIZE THE**  
11 **GUAM WATERWORKS**  
12 **AUTHORITY TO ISSUE**  
13 **PROCUREMENTS FOR GWA'S**  
14 **UPPER TUMON CAMPUS**  
15 **IMPROVEMENTS**

) **PETITION FOR GWA TO PROCURE**  
) **DESIGN-BUILD OF GWA'S UPPER**  
) **TUMON CAMPUS IMPROVEMENTS**

**DAMAGE ASSESSMENT/PROJECT WORKSHEET**

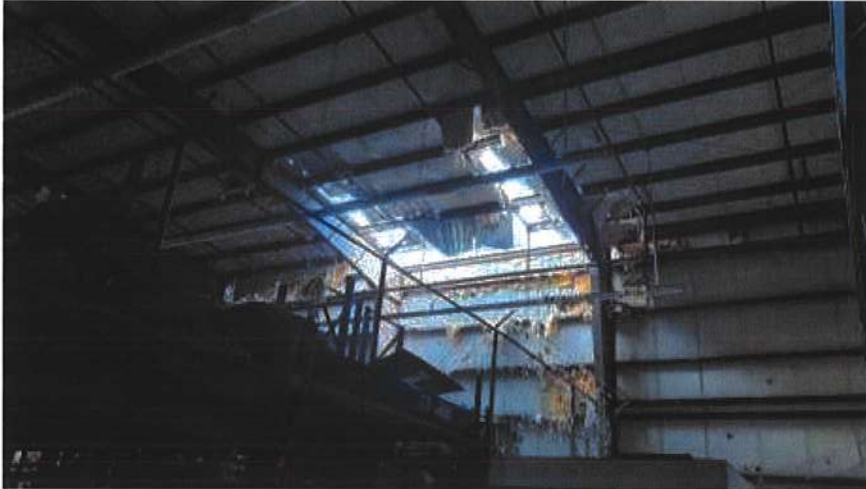
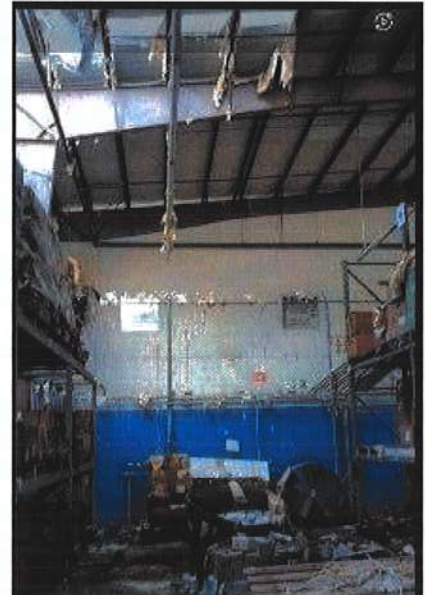
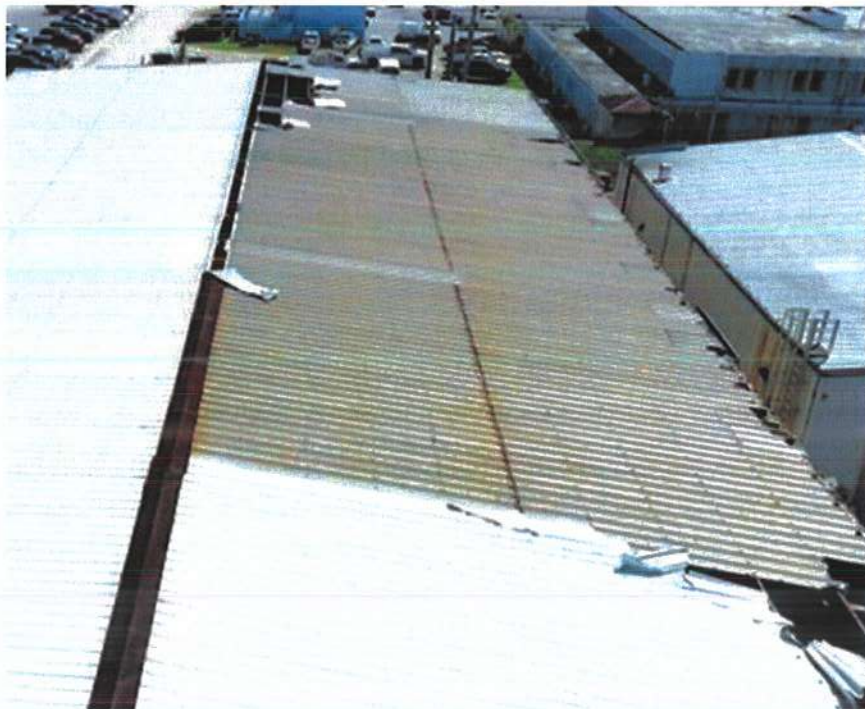
**ITEMS 1 & 1A- DAMAGED ROOFING BACKSIDE**

1. REMOVE DAMAGED BUTLERIB ROOF PANELS UP TO THE RIDGE INCLUDING INSULATION.
2. REPLACE DAMAGED BUTLERIB ROOFING PANELS UP TO THE RIDGE INCLUDING INSULATION.

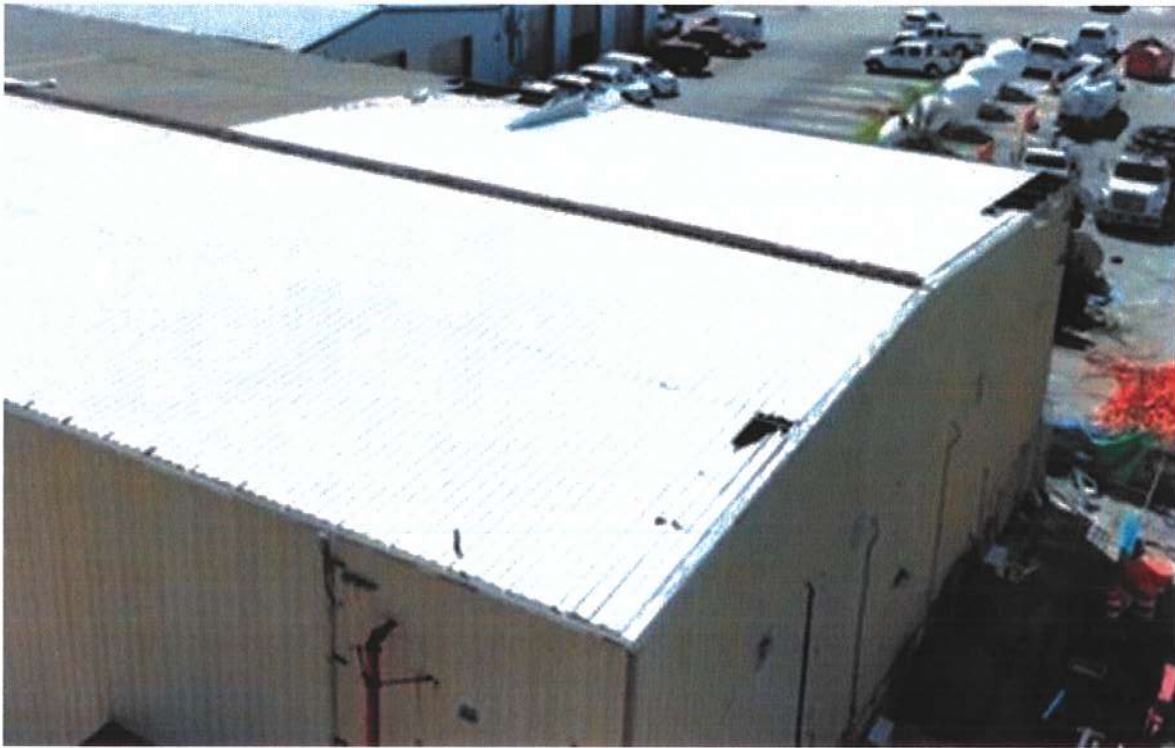
**ITEMS 2, 3 & 4– DAMAGED ROOFING AND FLASHING**  
**(RIGHT SIDE OF WAREHOUSE)**

3. REMOVE AND REPLACE ROOF FLASHING
4. REMOVE AND REPLACE ROOF GUTTER
5. REMOVAL AND DISPOSAL OD DAMAGED ACOUSTIC CEILING
6. REPLACE/INSTALL NEW ACOUSTIC CEILING TILES (GROUND AND Mezzanine FLOORS)

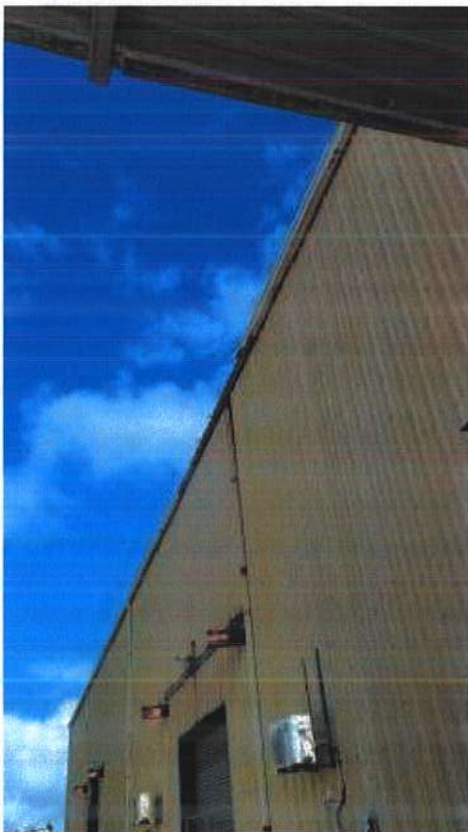
**ITEM 5 – DAMAGED ROOF**  
**GUTTER**  
**(FRONT OF WAREHOUSE)**

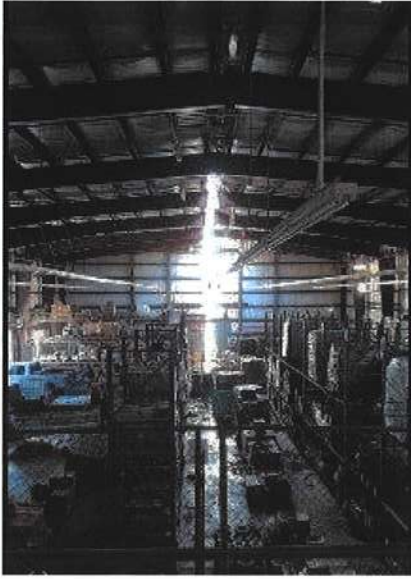
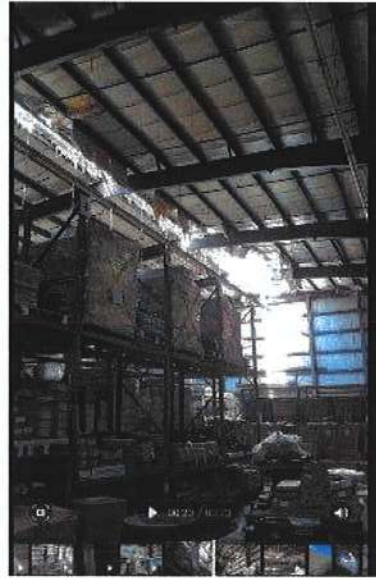
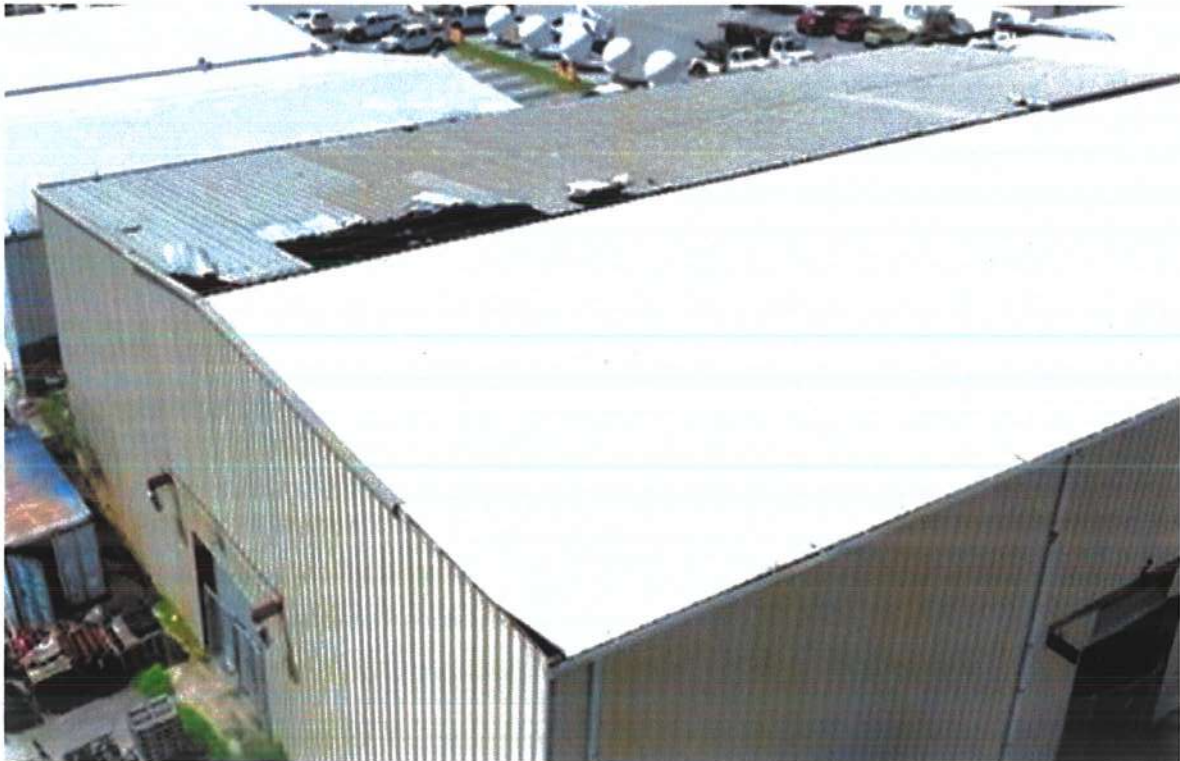
**ITEM 6 – DAMAGED ROOF RIDGE**

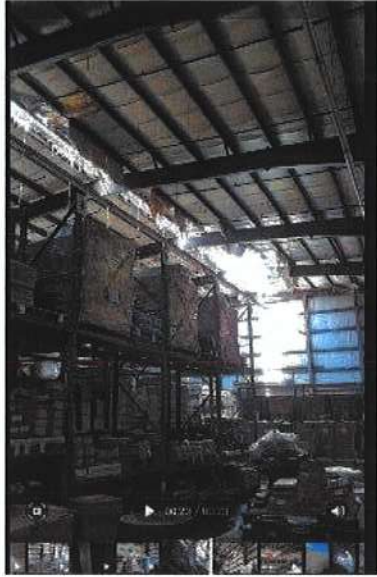
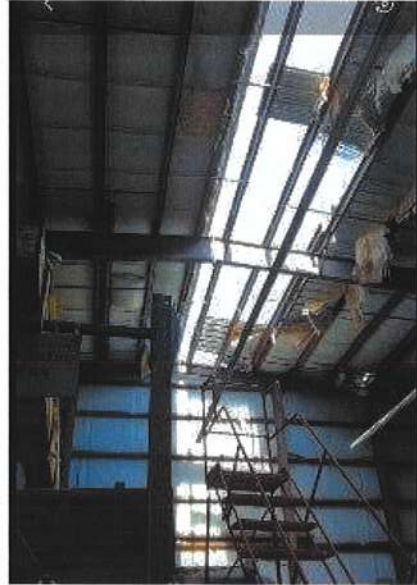
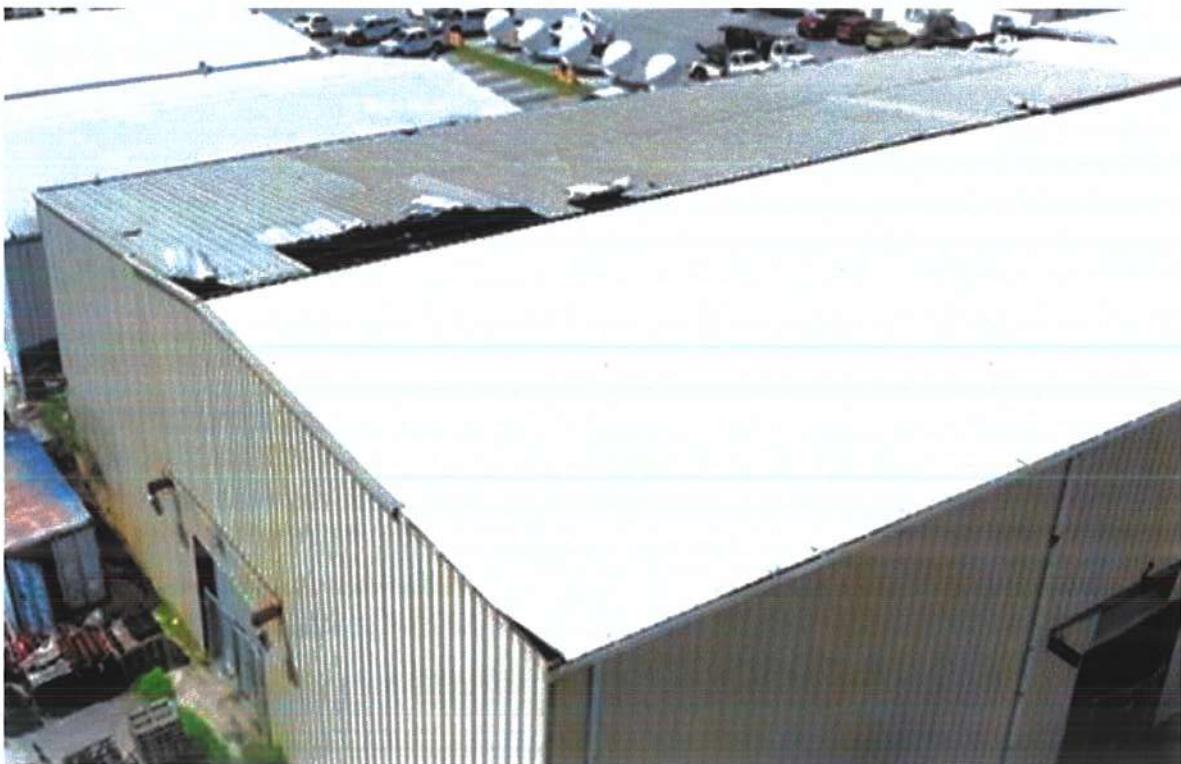
**ITEM 7 & 7A – DAMAGED ROOFING NEAR THE RIDGE OF THE WAREHOUSE**

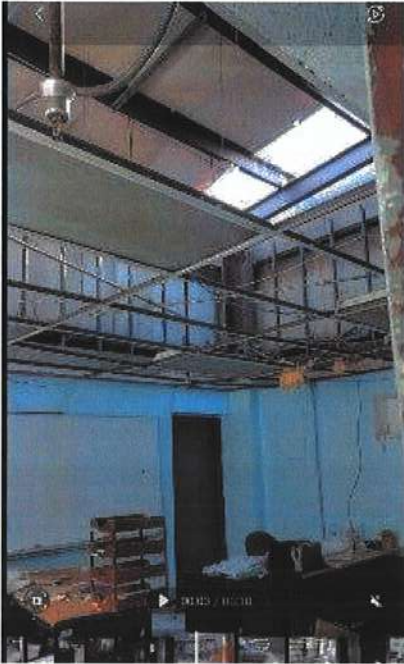
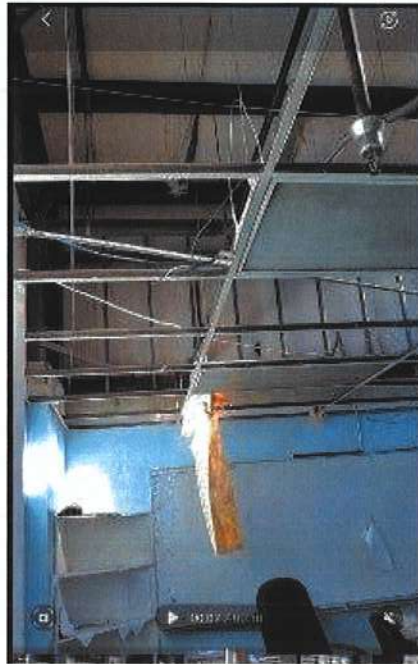
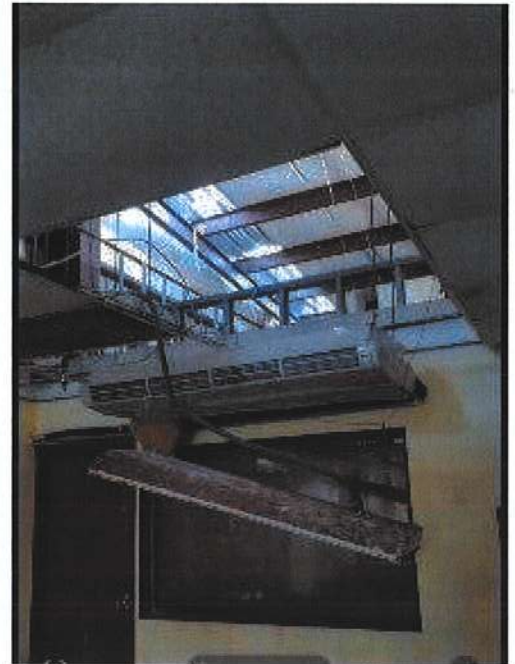
**ITEM 8 – DAMAGED ACOUSTIC CEILING AND WATER  
DAMAGED GYPSUM BOARD WALL  
WAREHOUSE MEZZANINE FLOOR**

7. REMOVE AND REPLACED WATER DAMAGED GYPSUM BOARDS, DOORS, AND WINDOWS AT GROUND FLOOR AND MEZZANINE FLOOR.
8. REPAINTING OF GYPSUM BOARDS, DOORS, AND WINDOWS AT GROUND FLOOR AND MEZZANINE FLOOR.

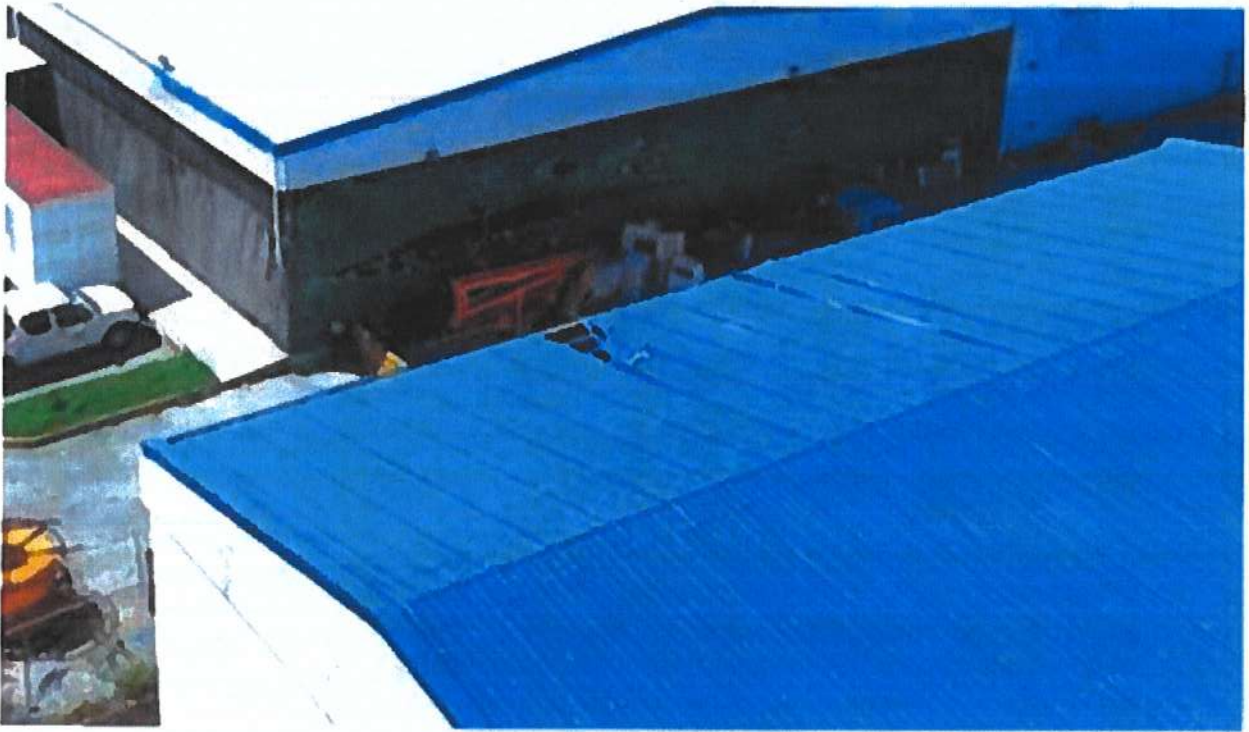
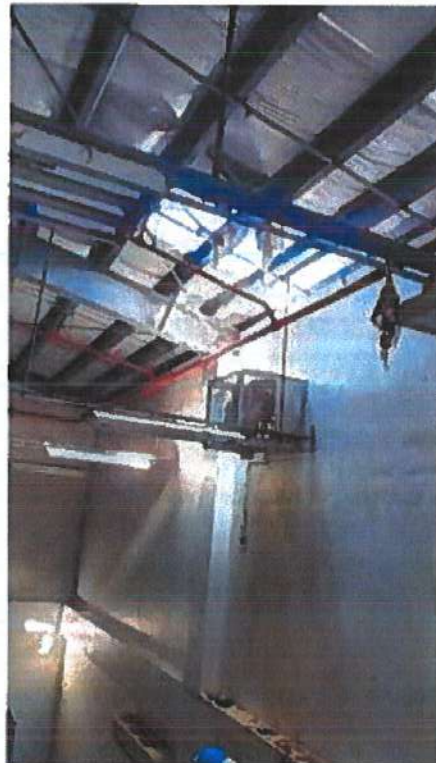
**1. APPROXIMATELY 99 SQUARE FEET OF BUTLERIB ROOFING WAS RIPPED OFF CAUSING WIND AND WATER DAMAGE TO THE OFFICE AREA AT THE SECOND FLOOR.**

**ITEMS 1 AND 2 – REMOVE AND REPLACE DAMAGED ROOFING  
PANELS UP TO ROOF RIDGE**

- 1. REMOVE DAMAGED BUTLERIB ROOF PANELS UP TO THE RIDGE INCLUDING INSULATION.**
- 2. REPLACE DAMAGED BUTLERIB ROOFING UP TO THE RIDGE INCLUDING INSULATION.**
- 3. REMOVE AND DISPOSE OF ALL ACOUSTIC CEILING TILES**
- 4. REPLACE ALL ACOUSTIC CEILING TILES.**
- 5. REMOVE MOLD INFESTED GYPSUM BOARD WALL**
- 6. REMOVE AND REPLACE WOODEN DOORS**
- 7. REPLACE GYPSUM BOARD WALL**
- 8. REPLACE WOODEN DOORS**
- 9. REPAINTING OF WALLS AND DOORS**
- 10. REMOVE AND REPLACE OF "NEW" AIR-CONDITION UNITS**
- 11. CLEAN FREE OF MOLDS THE AIR-INTAKE DUCTING**

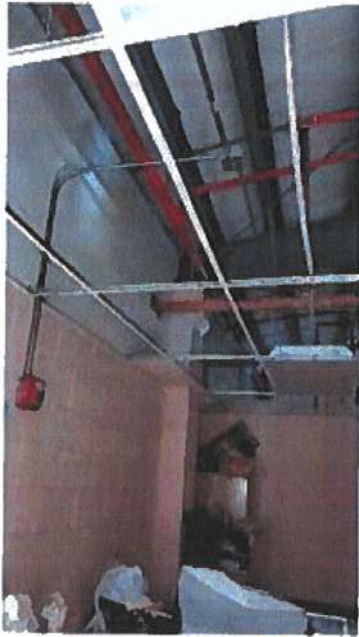
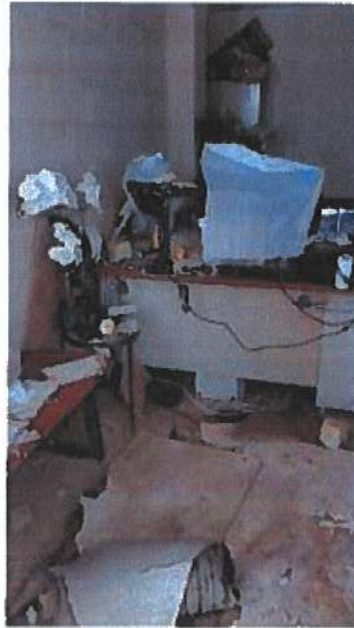
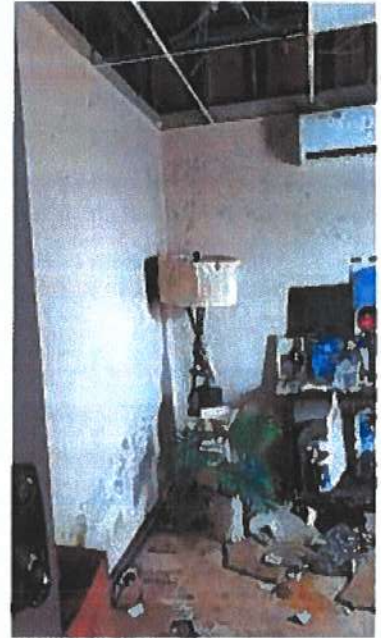
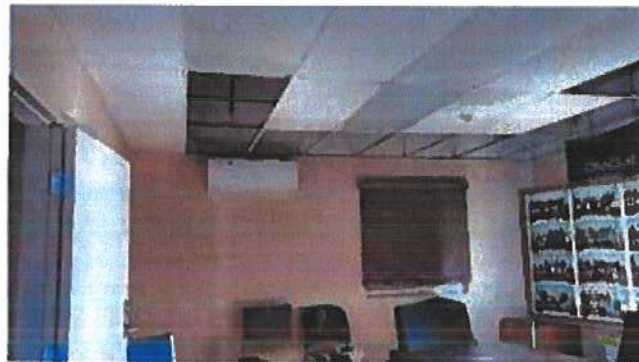
**2. THE ENTIRE ACOUSTIC CEILING TILES AT THE SECOND FLOOR NEED REPLACEMENT. MANY TILES DROPPED DOWN TO THE FLOOR AND DAMAGED, THOSE THAT REMAINED IN THE CEILING WERE ALSO WATER DAMAGED.**

**3. REMOVAL AND REPLACEMENT OF WATER DAMAGED GYPSUM BOARD WALLS INCLUDING DOORS AT SECOND FLOOR OFFICE.**

**ITEMS 3, 4, 5 AND 6 – METER TESTING FACILITY**

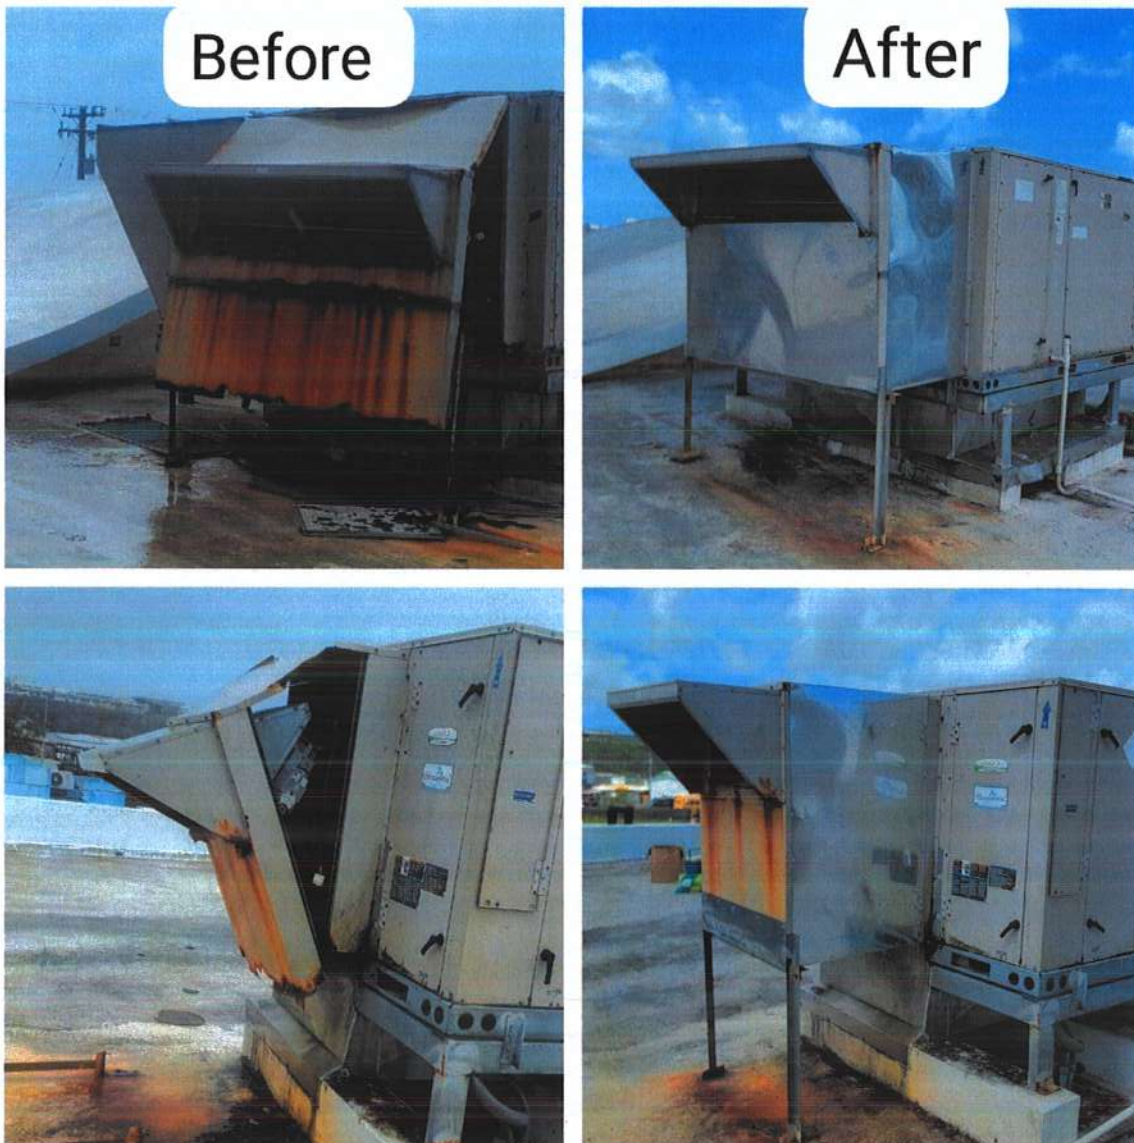
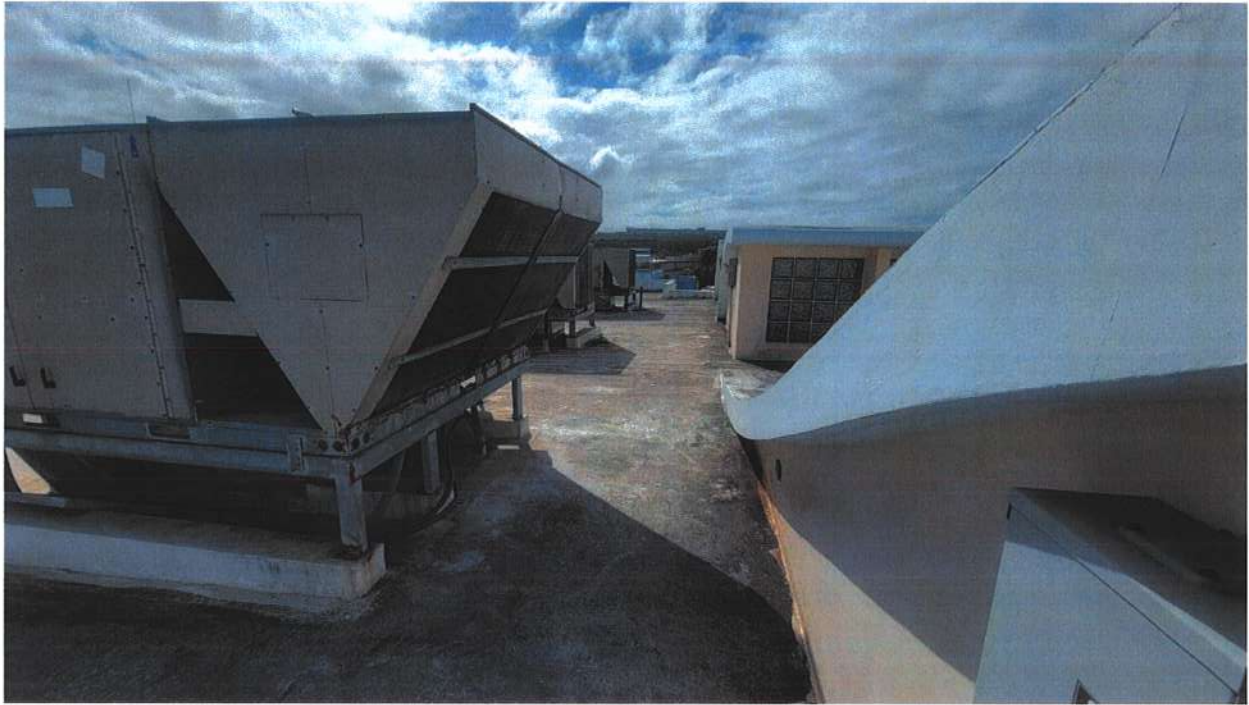
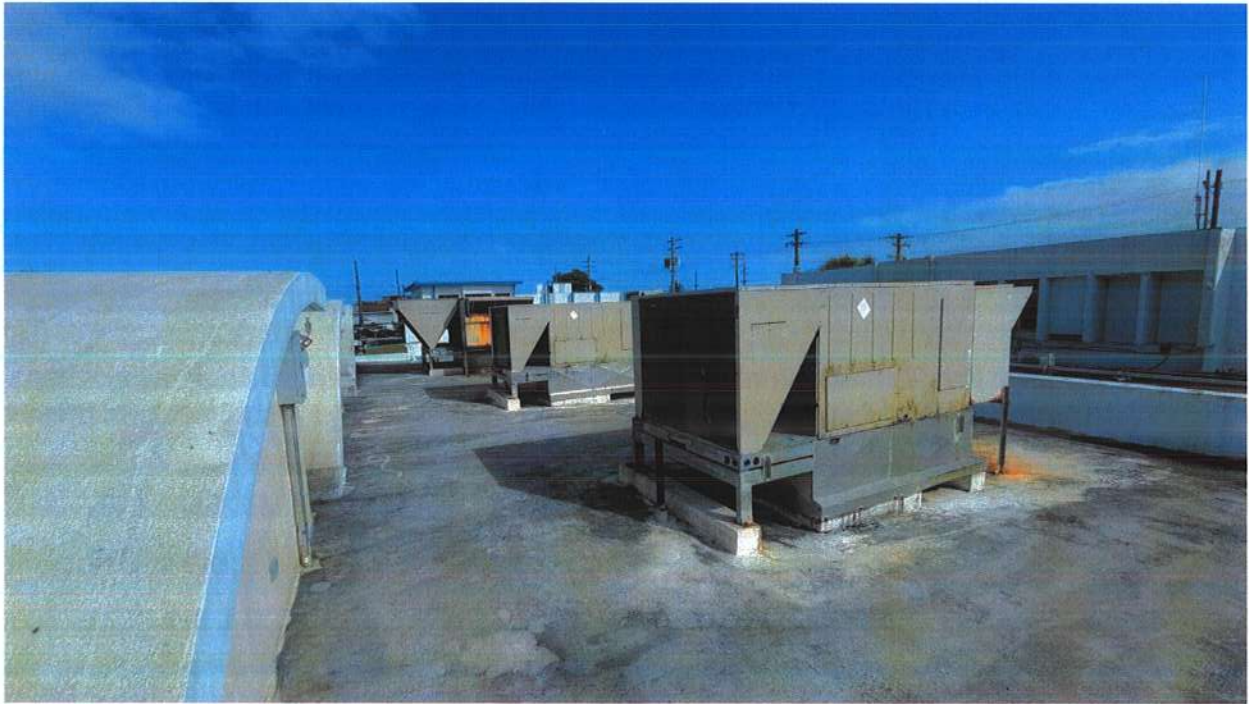
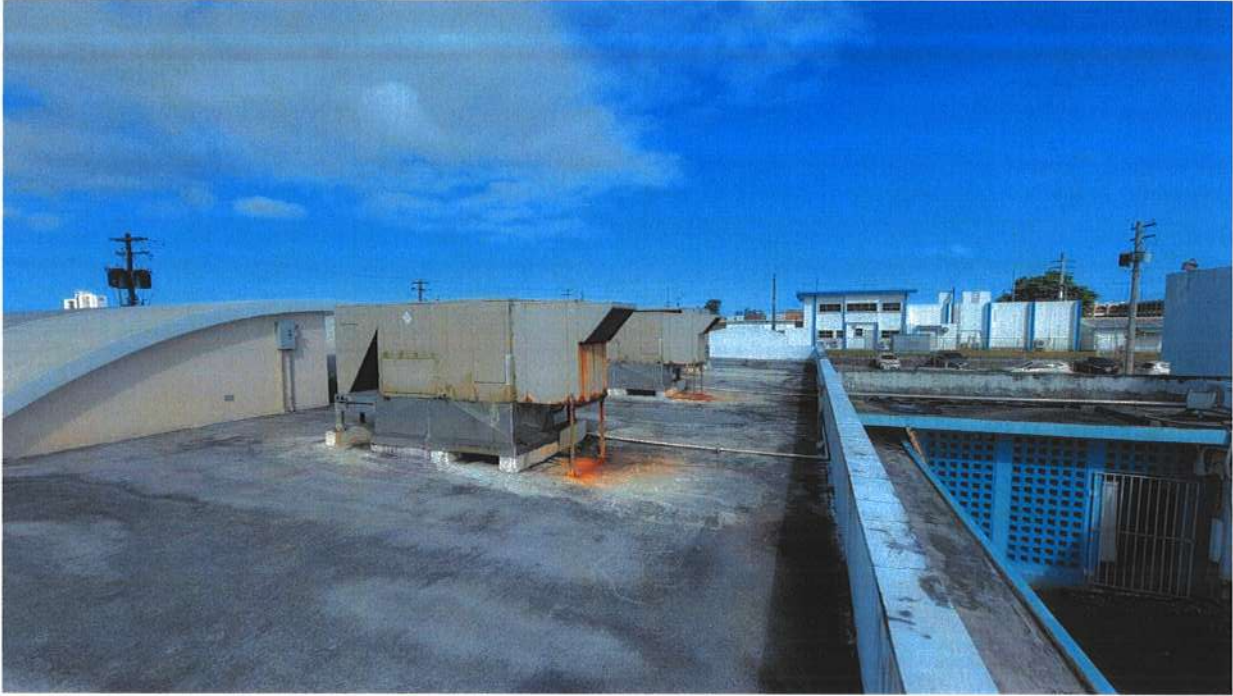
### 1.6 Conditions Found

The Guam Waterworks Authority (GWA) Compliance Facility has three (3) laboratories served by a designated package unit (PCU) for each zone. The PCU's utilize an outside air (OA) economizer where OA enters the return air mixing box for conditioning the humid air. The PCUs are constant volume.

The design intent specified a Dedicated Outside Air Unit (DOAU) that have specific technical features. A DOAU's are designed to condition 100% outside air at all times. Not all units PCUs are designed to handle 100% latency load. The GWA laboratories should adhere to ASHRAE guidelines for laboratory HVAC design. There are fume hoods in these spaces that require air to be all positively pressured.

The purpose of this document is establish the minimum acceptable technical requirements for the replacement of the DOAU equipment that serves the lab areas that includes the installation of a central controller dedicated for all three (3) DOAU's and permits further expansion utilizing an open protocol framework. This document also establishes the technical requirements for the contractors to comply with for submission.
